NASA APOLLO PROGRAM WORKING PAPER NO. 1333

AN INVESTIGATION OF APOLLO TITANIUM PRESSURE VESSEL  
WELDS MADE WITH COMMERCIAL PURE FILLER WIRE

MANNED SPACECRAFT CENTER  
HOUSTON, TEXAS  
January 1968

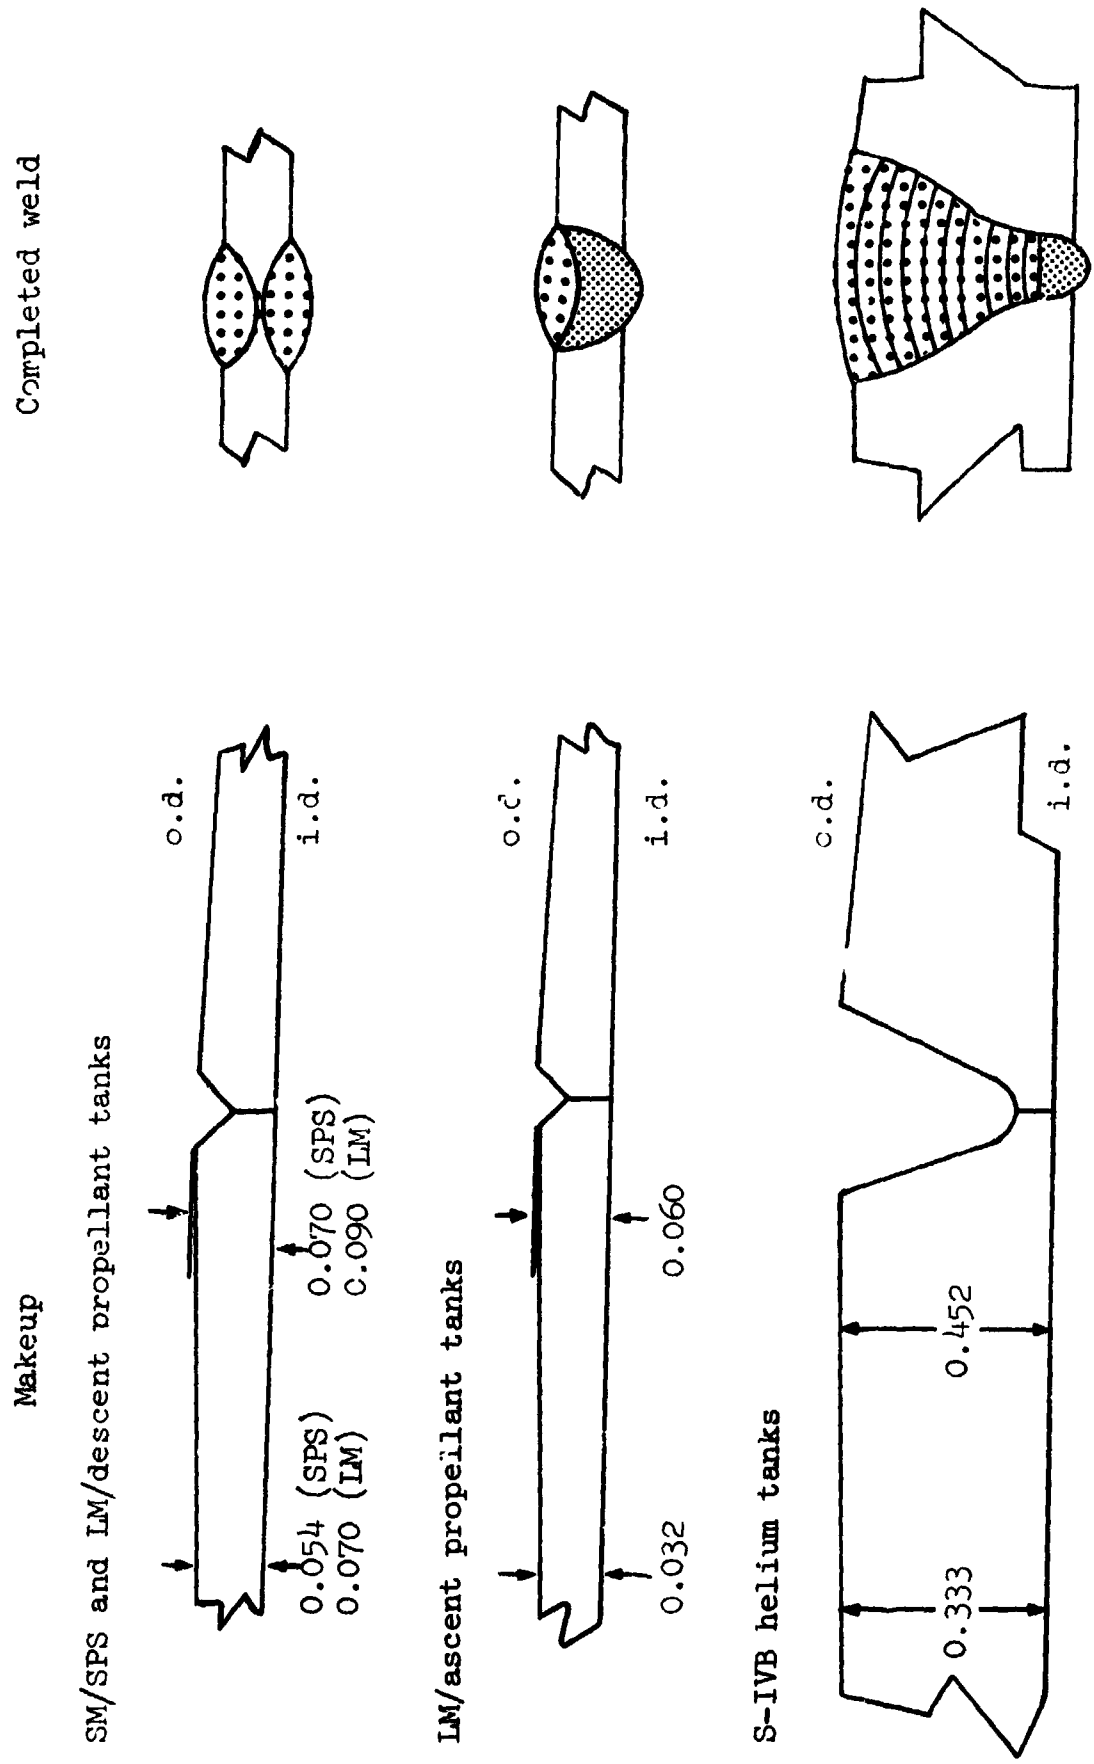
Figure 1.- Comparison of weld configuration (Apollo-Saturn).

A second significant difference in the welds is noted at the fusion line between weld metal and parent metal. The Saturn weld exhibits a very sharp, distinct fusion line while the Apollo welds do not. The absence of sharpness is indicative of the dissolution and higher alloy content in the Apollo welds. Figures 9, 10, and 11 show the Apollo and Saturn weld structures, respectively. Examination of the "worst case" Apollo weld repair (a double method 2 repair) where the alloy content would be expected to be the lowest, showed no banding or agglomeration of hydrides. One zone in the weld was analyzed to be nearly unalloyed titanium (see fig. 7, S/N 066) and contained a relatively large amount of small scattered titanium hydrides. Figure 12 shows the weld section. An enlargement of the low alloy portion is also shown which exhibits

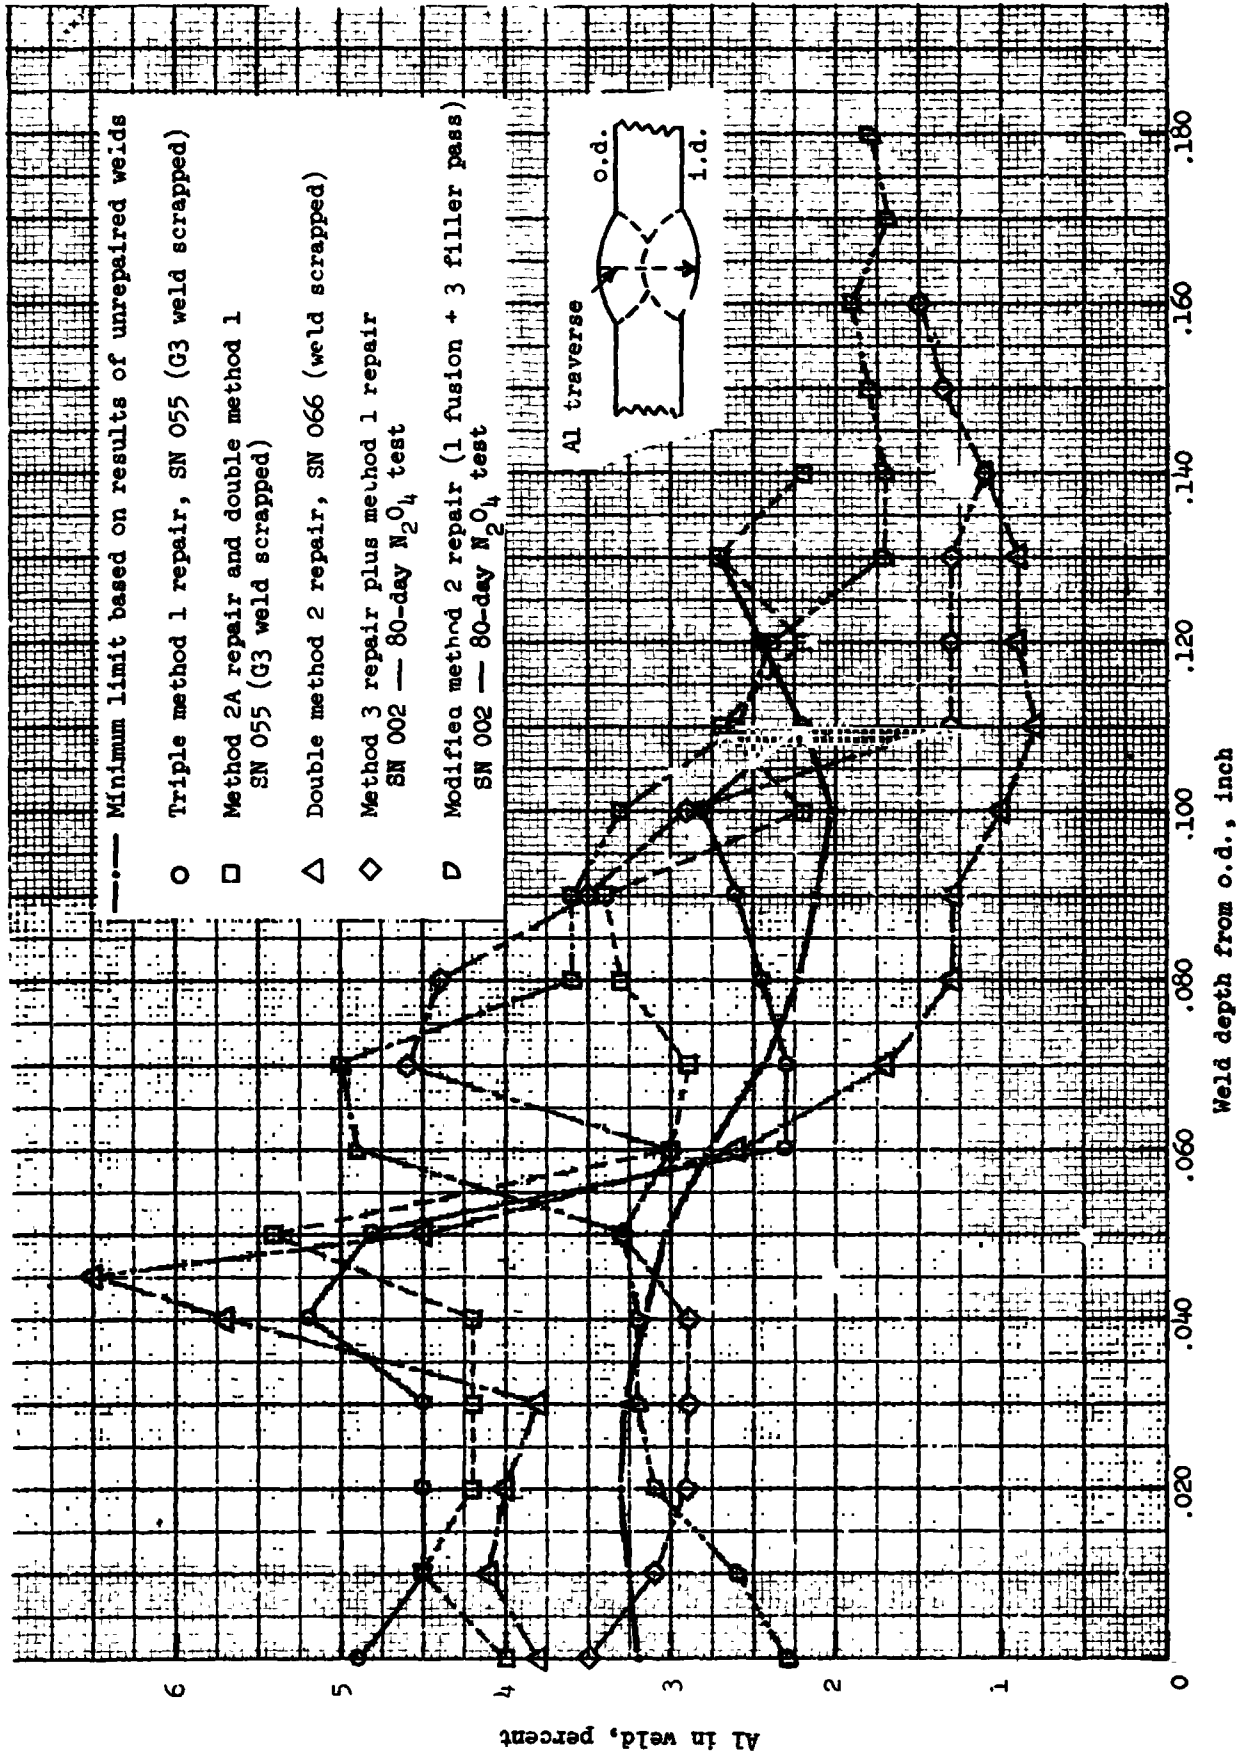
Figure 7.- Comparison of aluminum analysis in unrepaired and worst case repaired welds of SM/SPS propellant vessels.

Figures 6, 7, and 8 show the average and minimum compositions of the Apollo welds and weld repairs as determined by electron probe traverses. Hydrogen analyses of Apollo welds show the content to be less than 70 ppm in all cases examined.
